Mandatory Service Bulletin

SB-MD01-001

Jet System Engine Wiring Loom Damage Inspection and Repair

Type: JS-MD Single Model: JS-MD 1C MSN: all

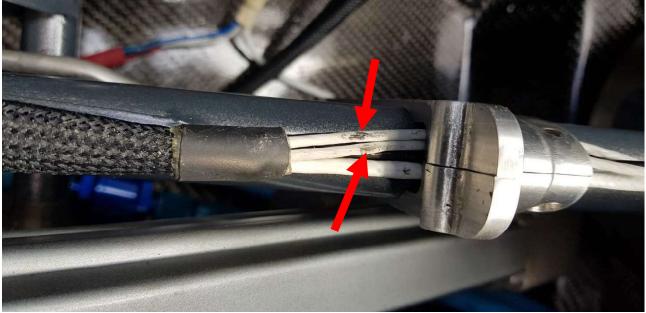
Due to chafing of the jet system wiring loom by souring of the pylon smouldering might occur.

Perform visual inspection. The damage can be seen in Figure A-1.

Figure A-1: Wiring Damage, pylon fairing moved downwards

Action 3 replacement of damaged wiring loom and installation of protective sleeving
