Service Bulletin EASA.21J.603

SB-MD10-003

Canopy Gas Strut Inspection

Type: JS-MD Single Model: JS-MD 3 All Serial Numbers

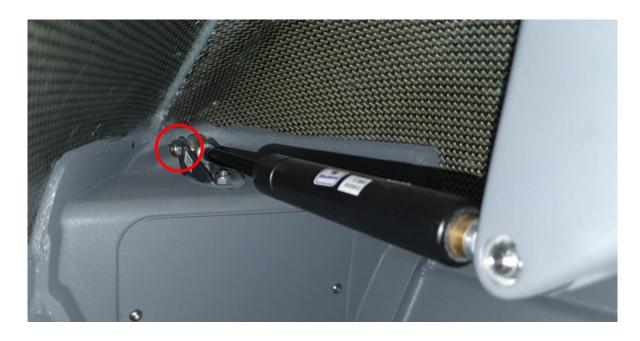
The binnacle gas strut of the JS3 model might be missing a securing nut on the front rod end. This SB serves as notice to inspect your binnacle gas strut, to ensure each rod end of the gas strut has its respective securing nut installed.

The illustration below indicates the location of the possibly missing M6 Nyloc self-locking nut. If this nut is missing, you will be required to install a nut with the following specification:

M6 Nyloc Self-Locking Nut

• Specification: BS EN ISO 3506

• Material: SS A2-70

• JS-MD Part No.: 104 04 010 00
